**STILL BOTTOMS POND AREA INTERIM ENGINEERED COVER
CONSTRUCTION COMPLETION REPORT
Including Fire Pond Closure**

**AMERICAN CHEMICAL SERVICE NPL SITE
GRIFFITH, INDIANA**

MWH File No. 2090601

MARCH 26, 2004
Date

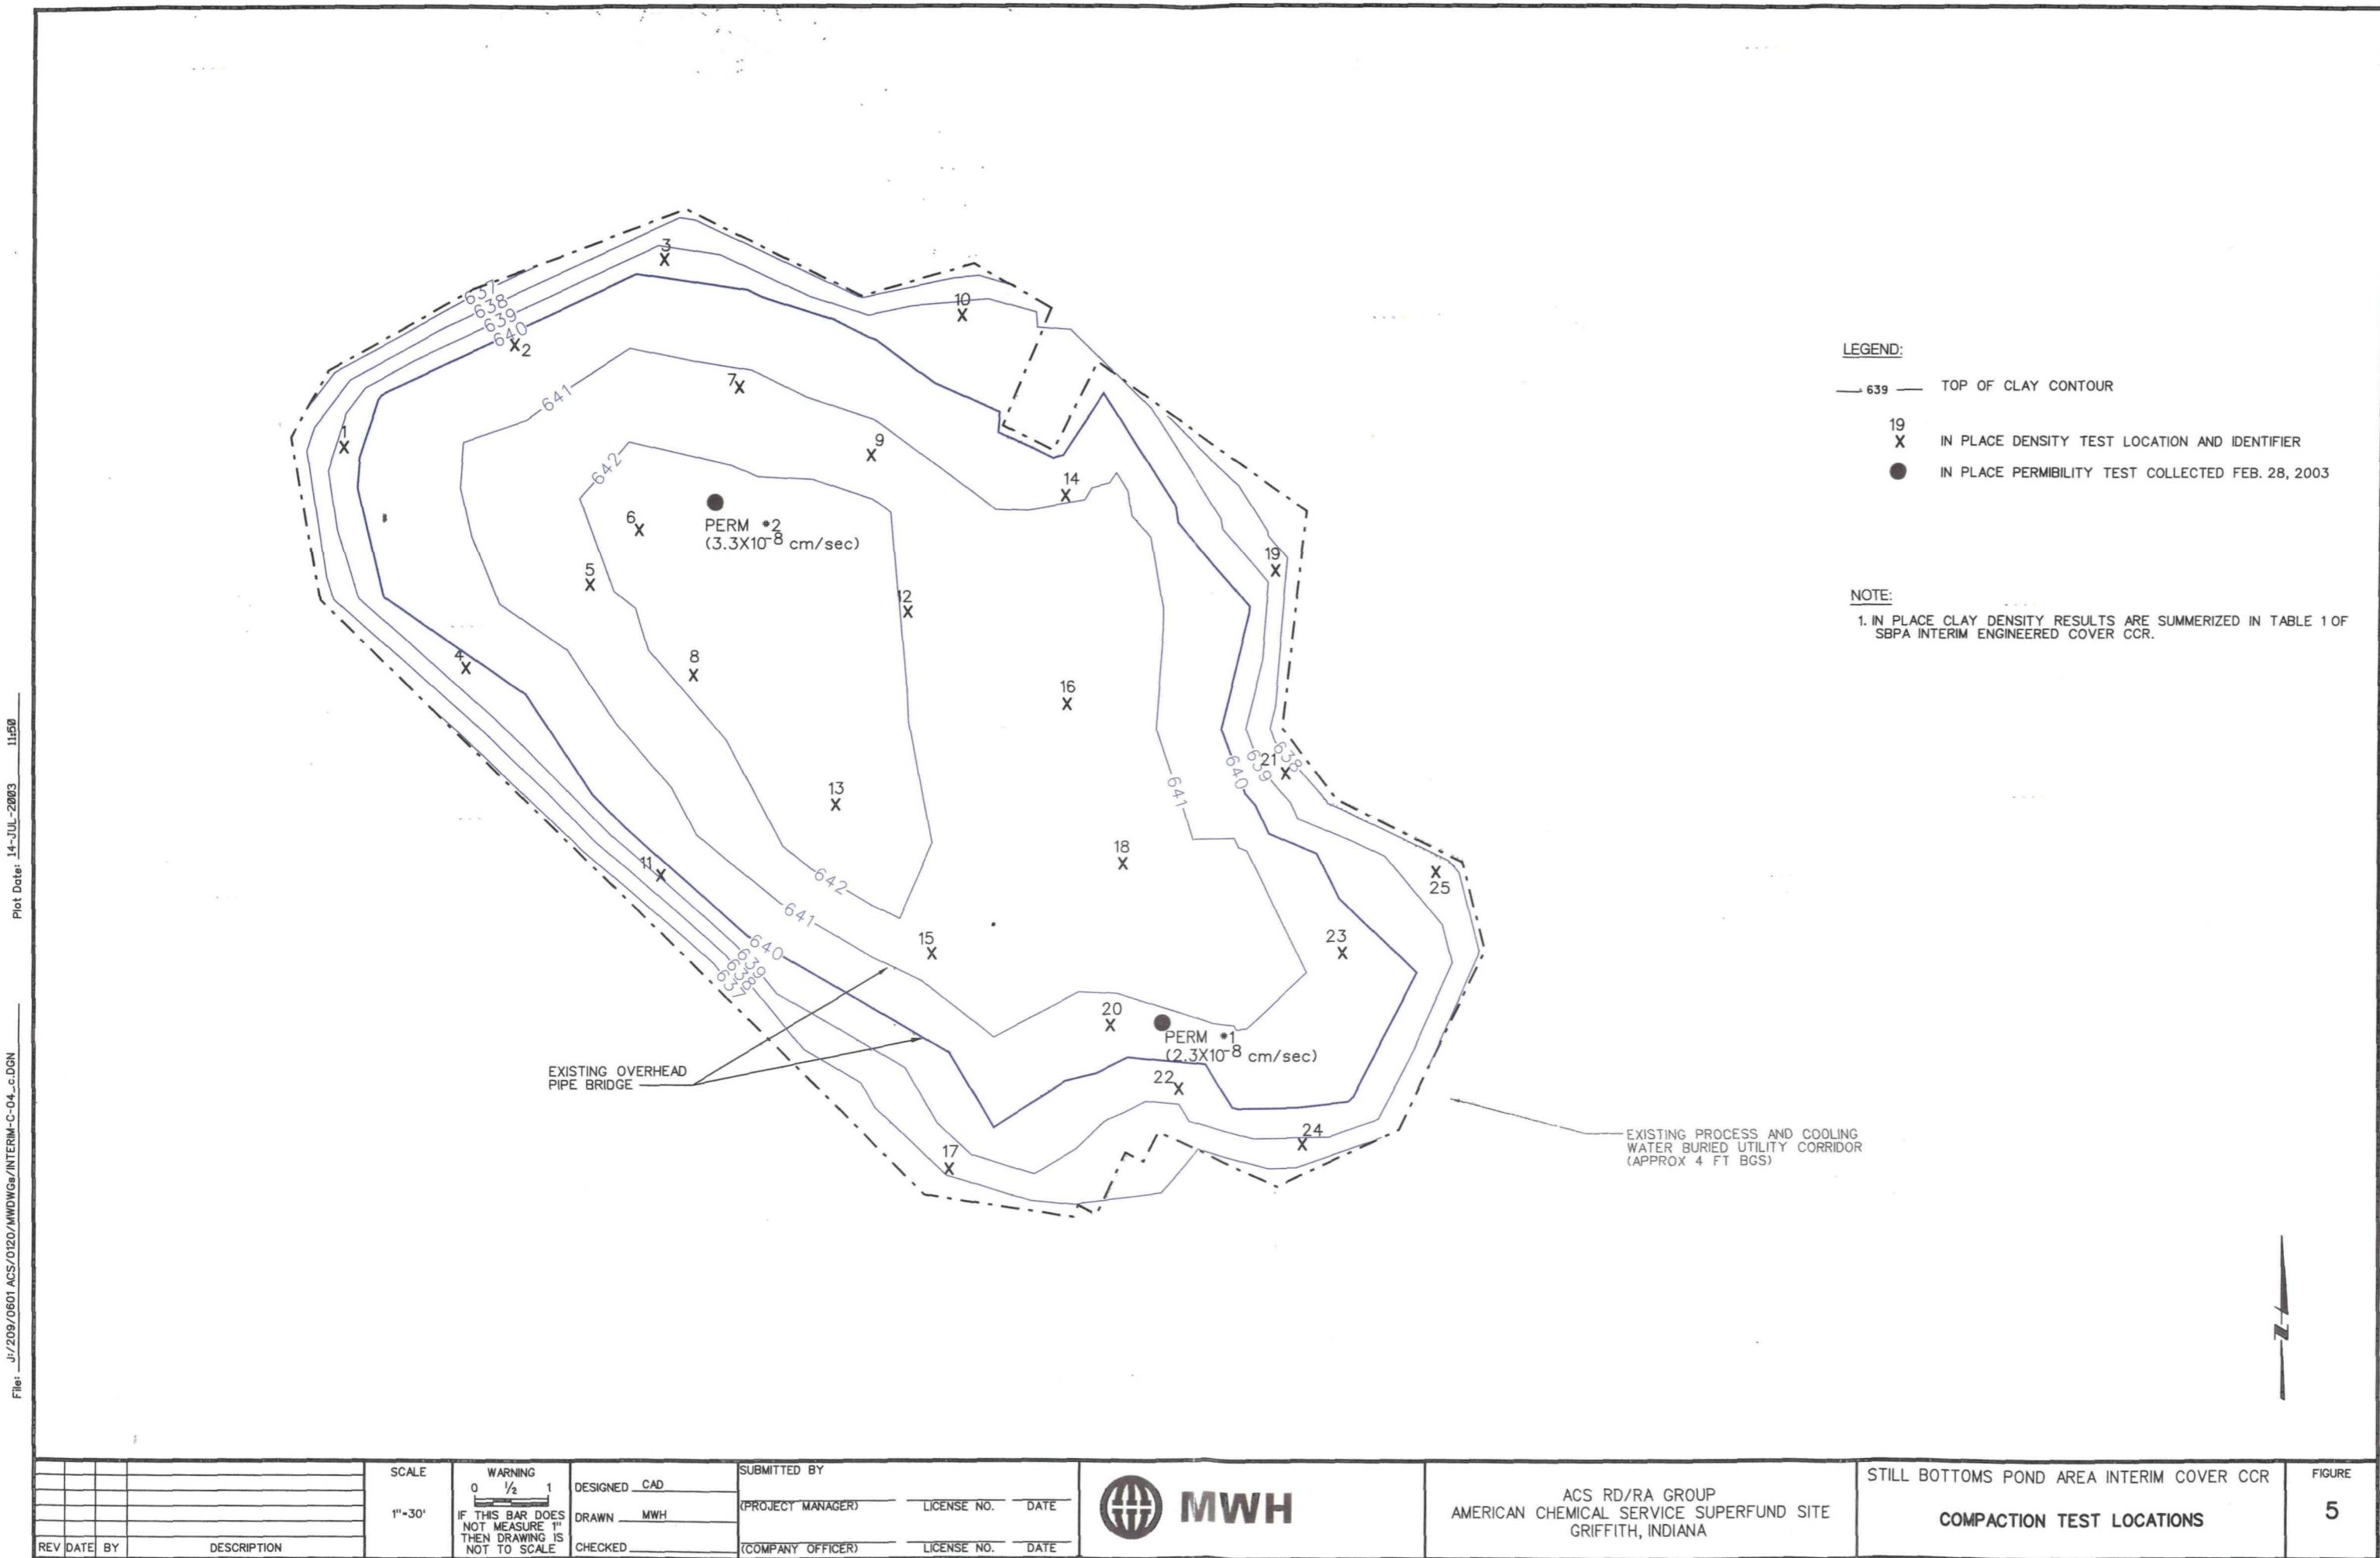
FIGURE
5

Great Lakes conducted in-place soil density testing on the installed clay. The clay was tested to verify that it was compacted to 95% of maximum dry density at the optimum moisture range. Each six-inch lift was tested at a frequency of eight tests per acre and the testing was conducted with a nuclear density testing unit. Nuclear density testing was performed at all locations and sand cone tests were performed at two of these locations as a quality control measure.

The field quality assurance test results were compared to the maximum dry density and optimum moisture as determined in the laboratory. If either the density or moisture requirements were not met, the non-passing areas were reworked (recompacted, rewetted, or both) and retested until the criteria were met. As Table 1 shows, all locations eventually met the compaction and moisture requirements. It should be noted that on the first day of compaction testing (October 10, 2002) the wrong Proctor value for dry density was used. This was corrected on subsequent days of testing.

STILL BOTTOMS POND AREA INTERIM COVER CCR
COMPACTION TEST LOCATIONS

HHSI reworked deficient clay areas to meet the compaction requirements.

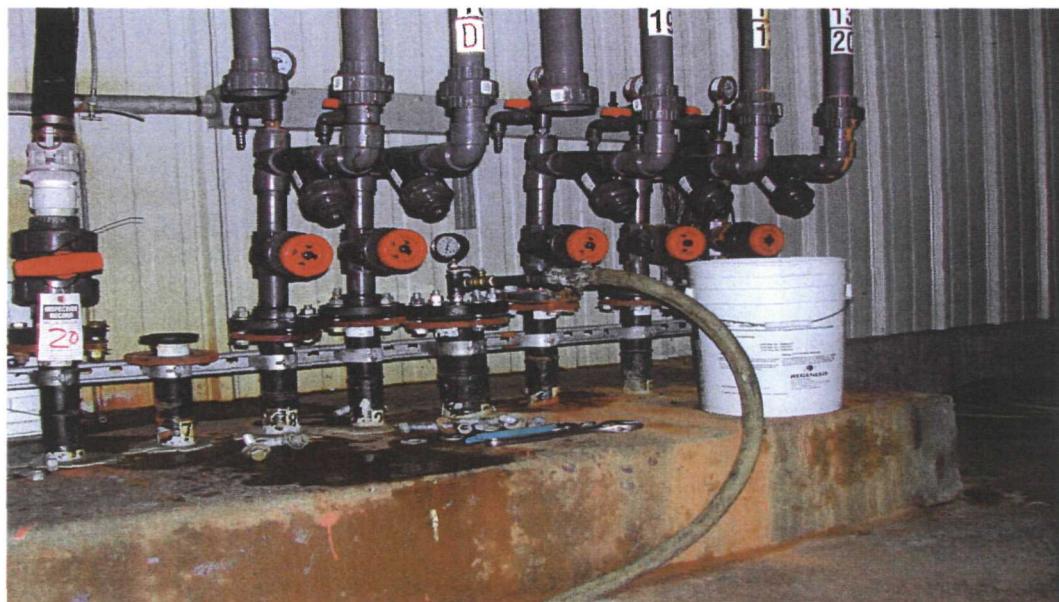
All conveyance piping installed during the completion of the SBPA interim cover was pressure tested and found to be without leakage. Two-inch diameter and three-inch diameter pipes were pressure tested at 90 psi for 15 minutes. Ninety psi was selected for the pressure testing because it is the maximum pressure that the GWTP's air compressor can generate within the pipes. While pressure testing the eight-inch diameter pipes, it was determined that the gasket on the pressure coupling could not hold more than 60 psi before the gasket would fail. This situation presented a potential health and safety concern for the field testing crew. Therefore, it was determined that the eight-inch lines would be pressure tested at 50 psi for 30 minutes. A test pressure of 50 psi still provides a factor of safety of 10 times the maximum operating pressure for the eight-inch diameter pipes. Information of this conveyance piping will also be included in the future Construction Completion Report for the SBPA ISVE System and On-Site Area BWES Upgrades. A copy of the pipe manufacturer's specifications is included in Appendix D.

5. September 2002: Pressure testing conveyance lines. Each line maintained 90 psi +/-2% for 15 minutes.

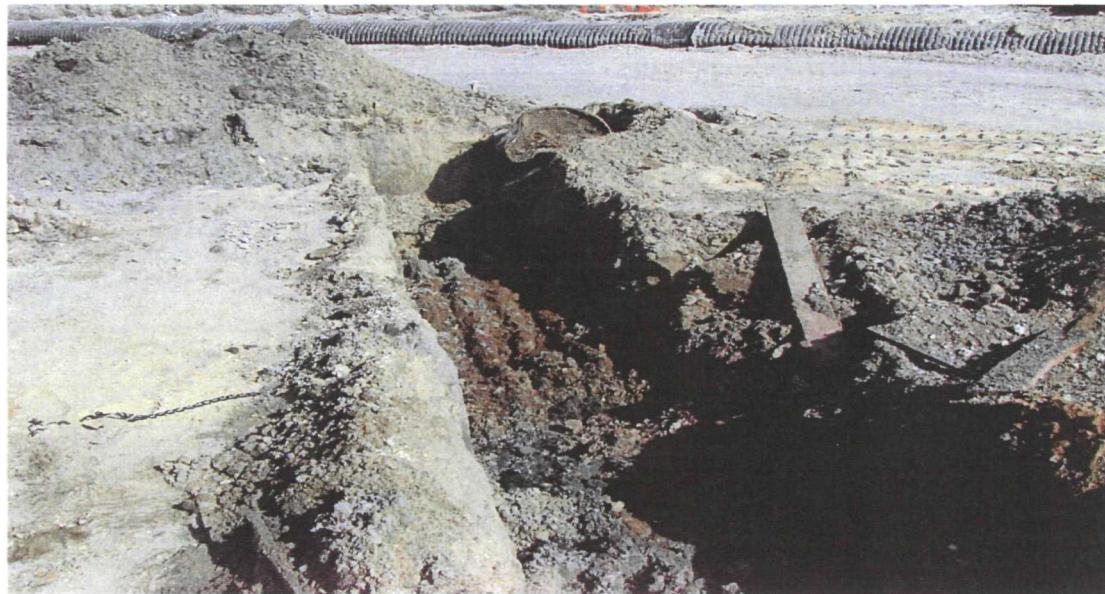
The second area where drum carcasses and debris was encountered was in the northeast corner of the cover area where debris was observed at approximately two feet below ground surface (bgs). Due to the potential for uncovering more debris and in order not to disturb the drum carcasses already encountered, the pipe in this area was installed at a depth of approximately one and a half feet bgs. Because the groundwater extraction piping runs in a loop, no pumps would be isolated if freezing occurs in the shallower pipe section. Therefore, the shallower pipe location is considered to be acceptable.

6. October 2002 (Looking North): Drum carcasses and debris encountered on the Northeast edge of the cover area.

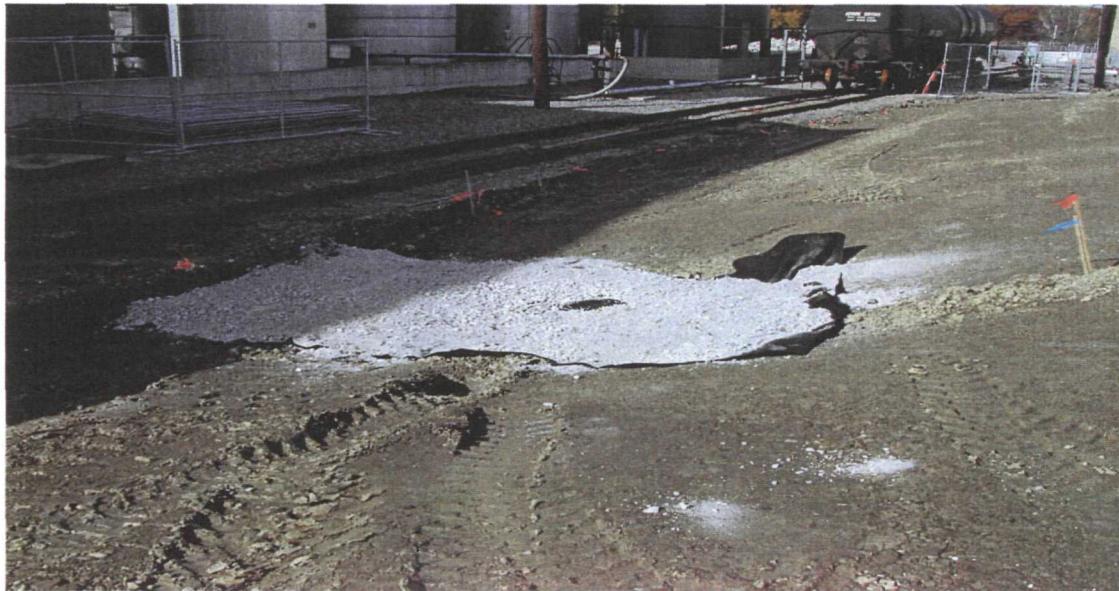
In four areas around the perimeter of the site, the clay could not be placed and compacted to the required depth of 12-inches due to shallow storm water piping and/or catch basins. Because specific elevations needed to be maintained across the site, additional subbase material could not be placed over these areas. It was determined that without this additional material, placing and compacting the clay had a high potential to damage pipe and/or catch basins. Therefore, to achieve the required permeability rate of the cover, 60-mil flexible membrane liner (FML) was placed over these areas. The FML utilized was from an extra roll of the FML used for the Off-Site Area final cover. Material properties of this material will be submitted in the Construction Completion Report for the Off-Site Area final cover. To facilitate placement around catch basins, a hole was cut in FML to slide it over the catch basin and the gap between the FML and the catch basin was then sealed with bentonite grout. A piece of geofabric was then placed over the FML to protect the FML from damage and gravel was placed over these areas to achieve the design grades. These locations are shown on Figure 6, along with an installation detail.

10. November 2002 (Looking Southwest): Stormwater catchbasin and pipe after placement of FML, bentonite seal, geofabric, and stone.
